**QUALITATIVE ASSESSMENT  
For  
SR 44 at Continental Boulevard**

Sumter County  
Section 1807000  
Mile Post 15.938

**THE FLORIDA DEPARTMENT OF TRANSPORTATION  
DISTRICT 5 TRAFFIC OPERATIONS**

April 2020

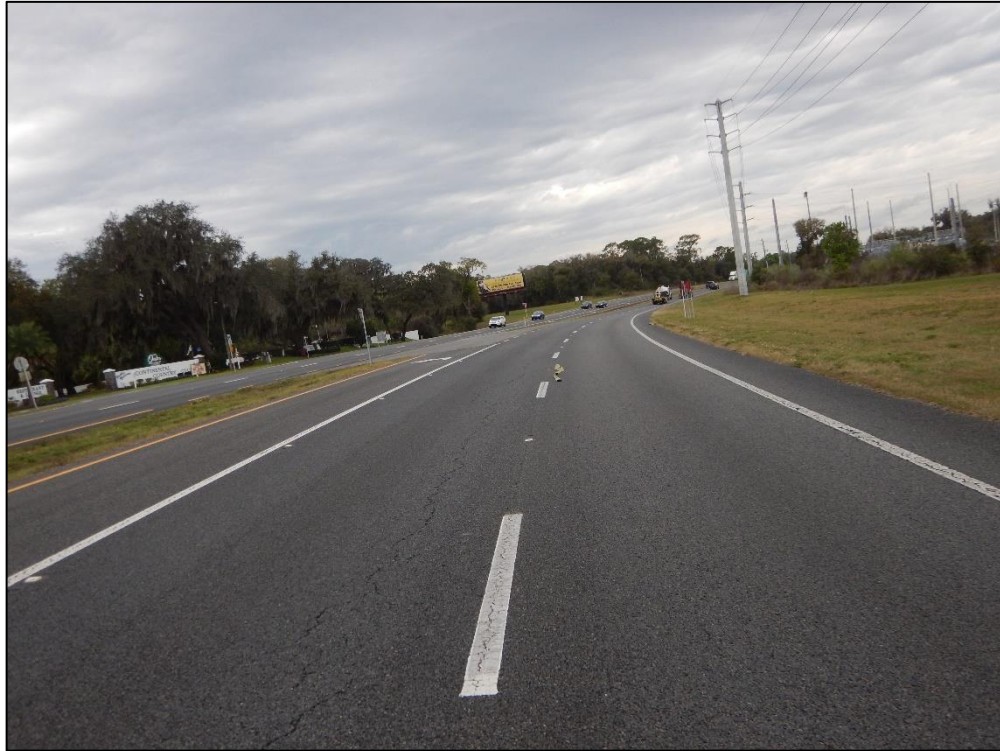
Exhibit 1: Looking west into the intersection along SR 44

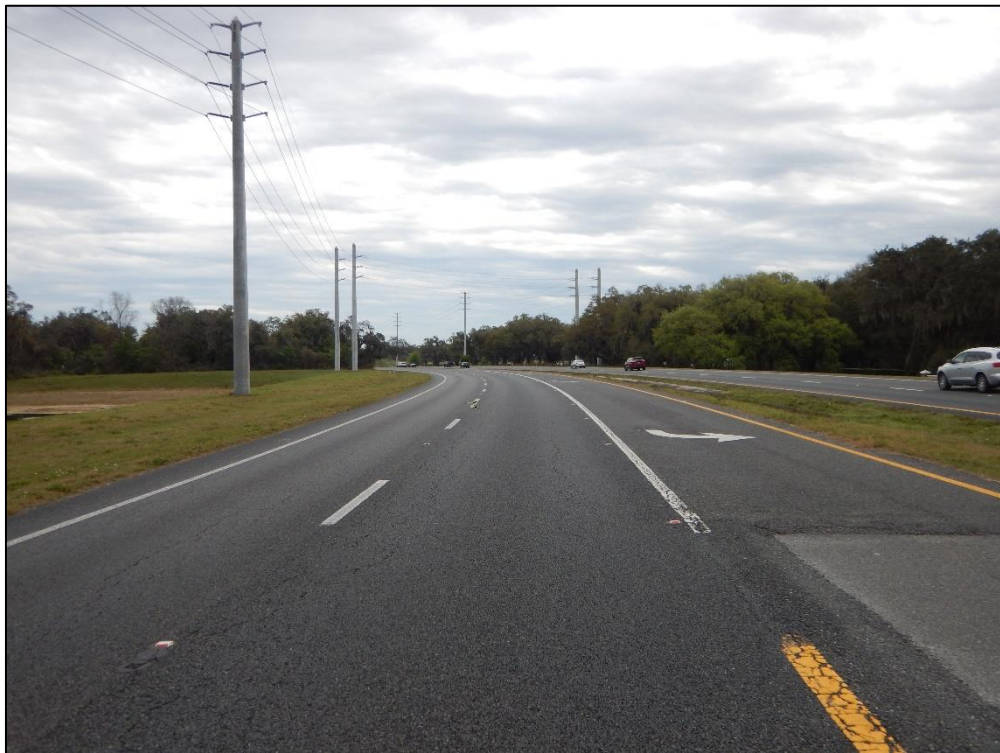
Exhibit 2: Looking east from the intersection along SR 44

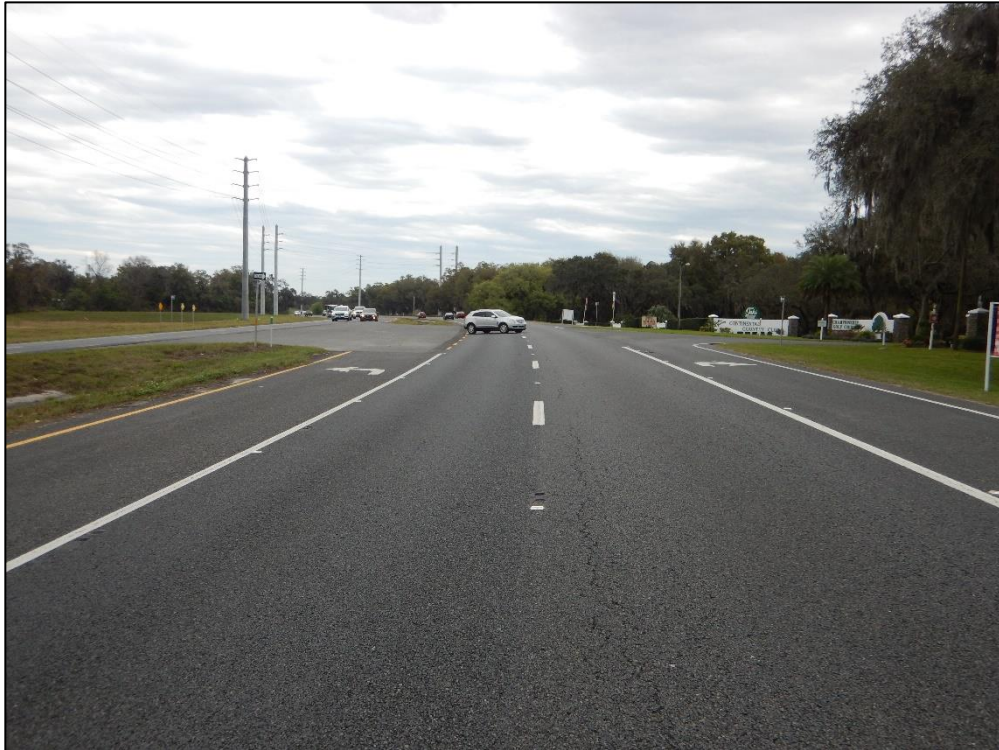
Exhibit 3: Looking east into the intersection along SR 44

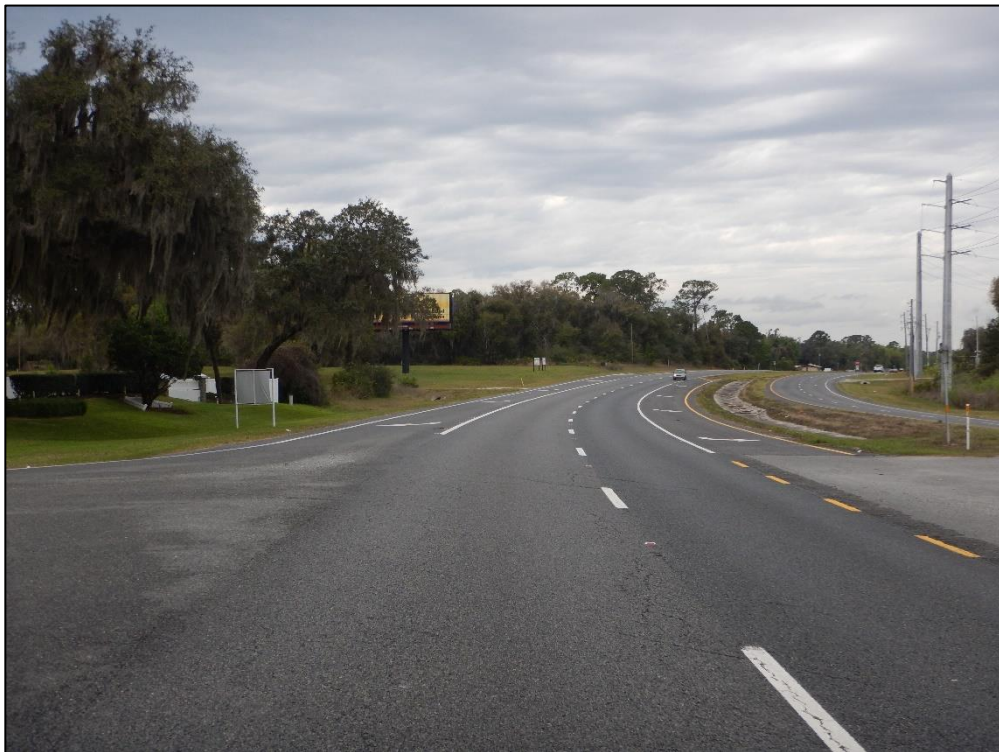
Exhibit 4: Looking west from the intersection along SR 44

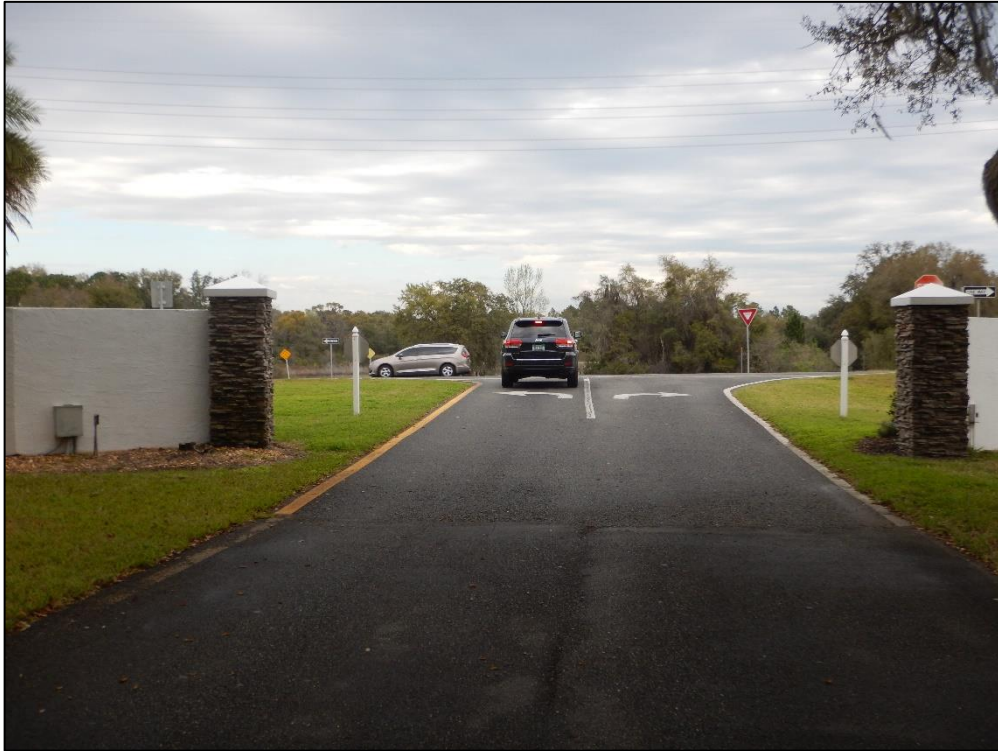
Exhibit 5: Looking north into the intersection along Continental Boulevard

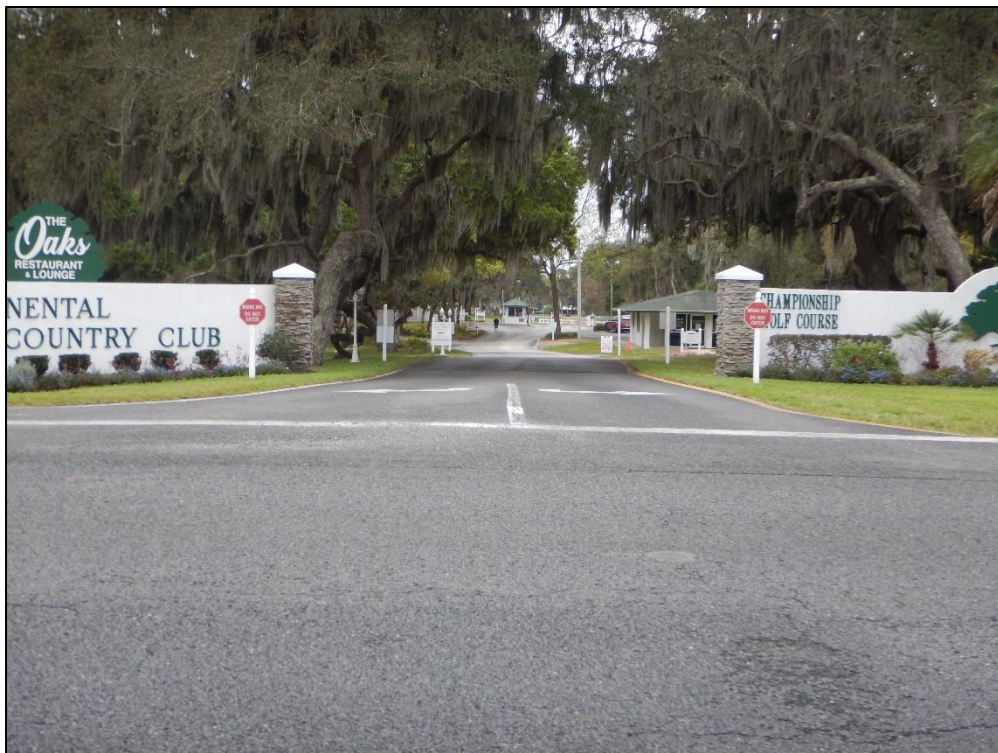
Exhibit 6: Looking south from the intersection along Continental Boulevard

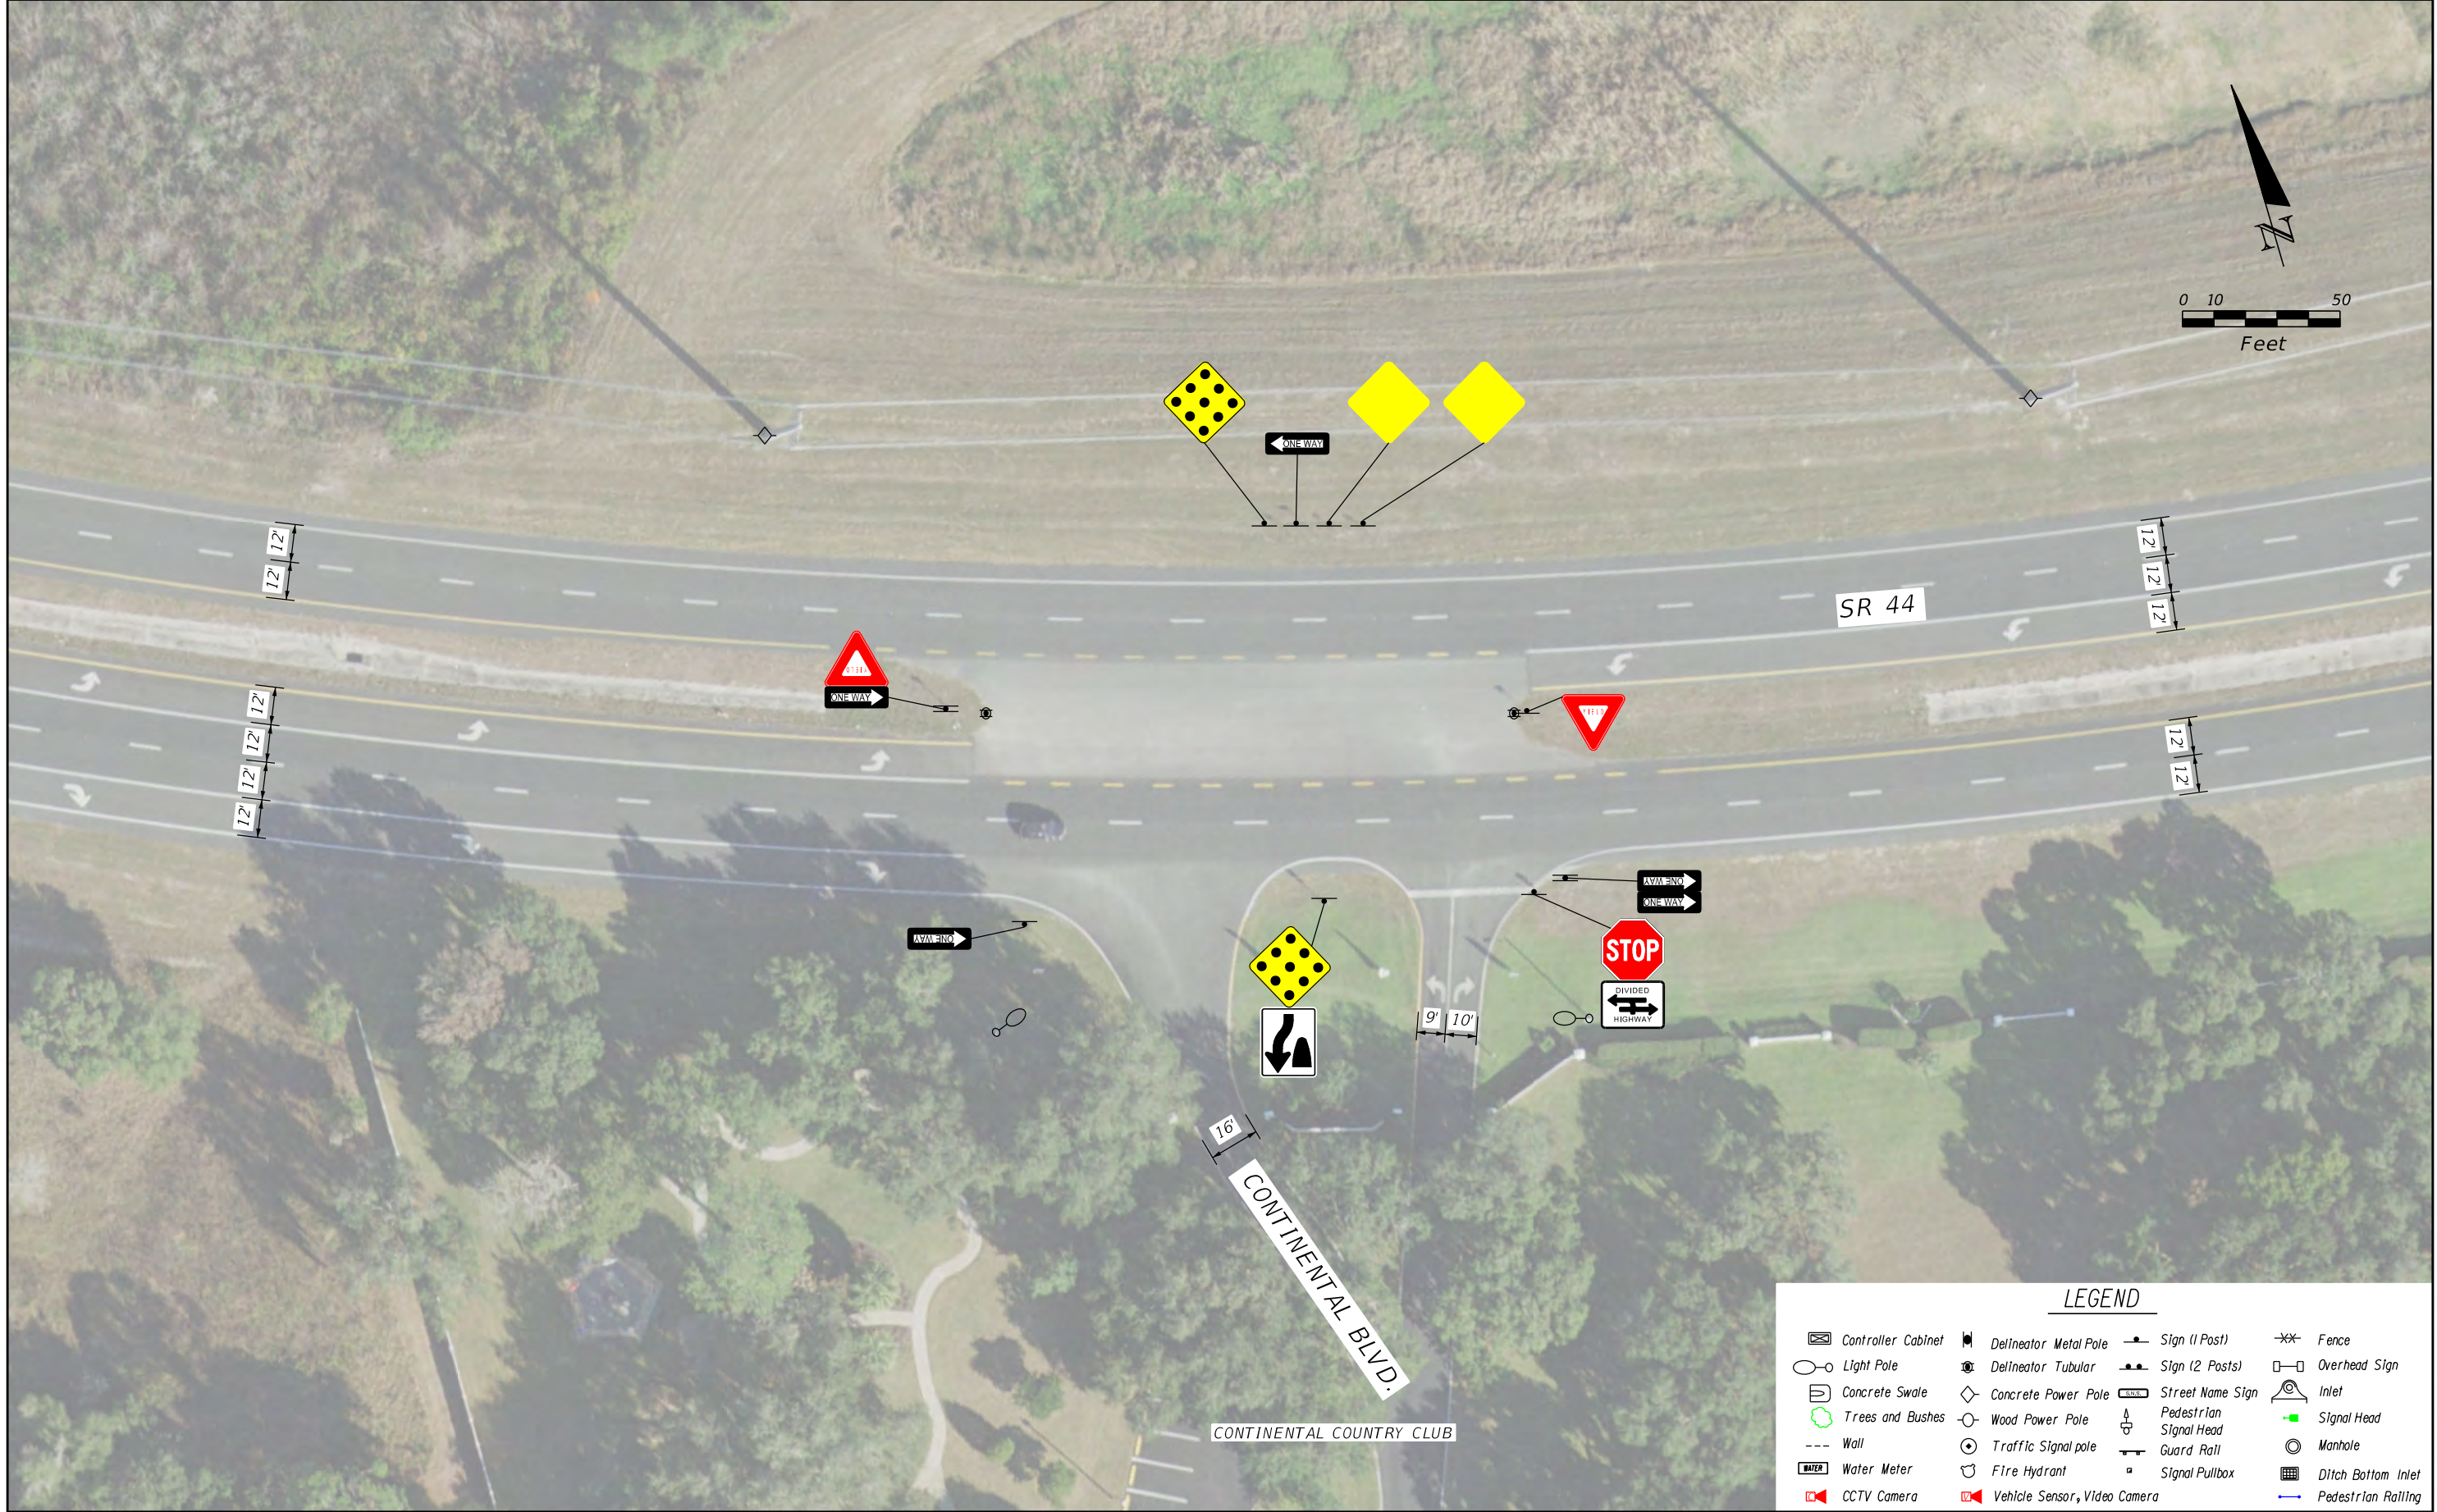
SHEET NO.
1

<b>CONDITION DIAGRAM</b> <b>SR44 AT CONTINENTAL BLVD</b>
---

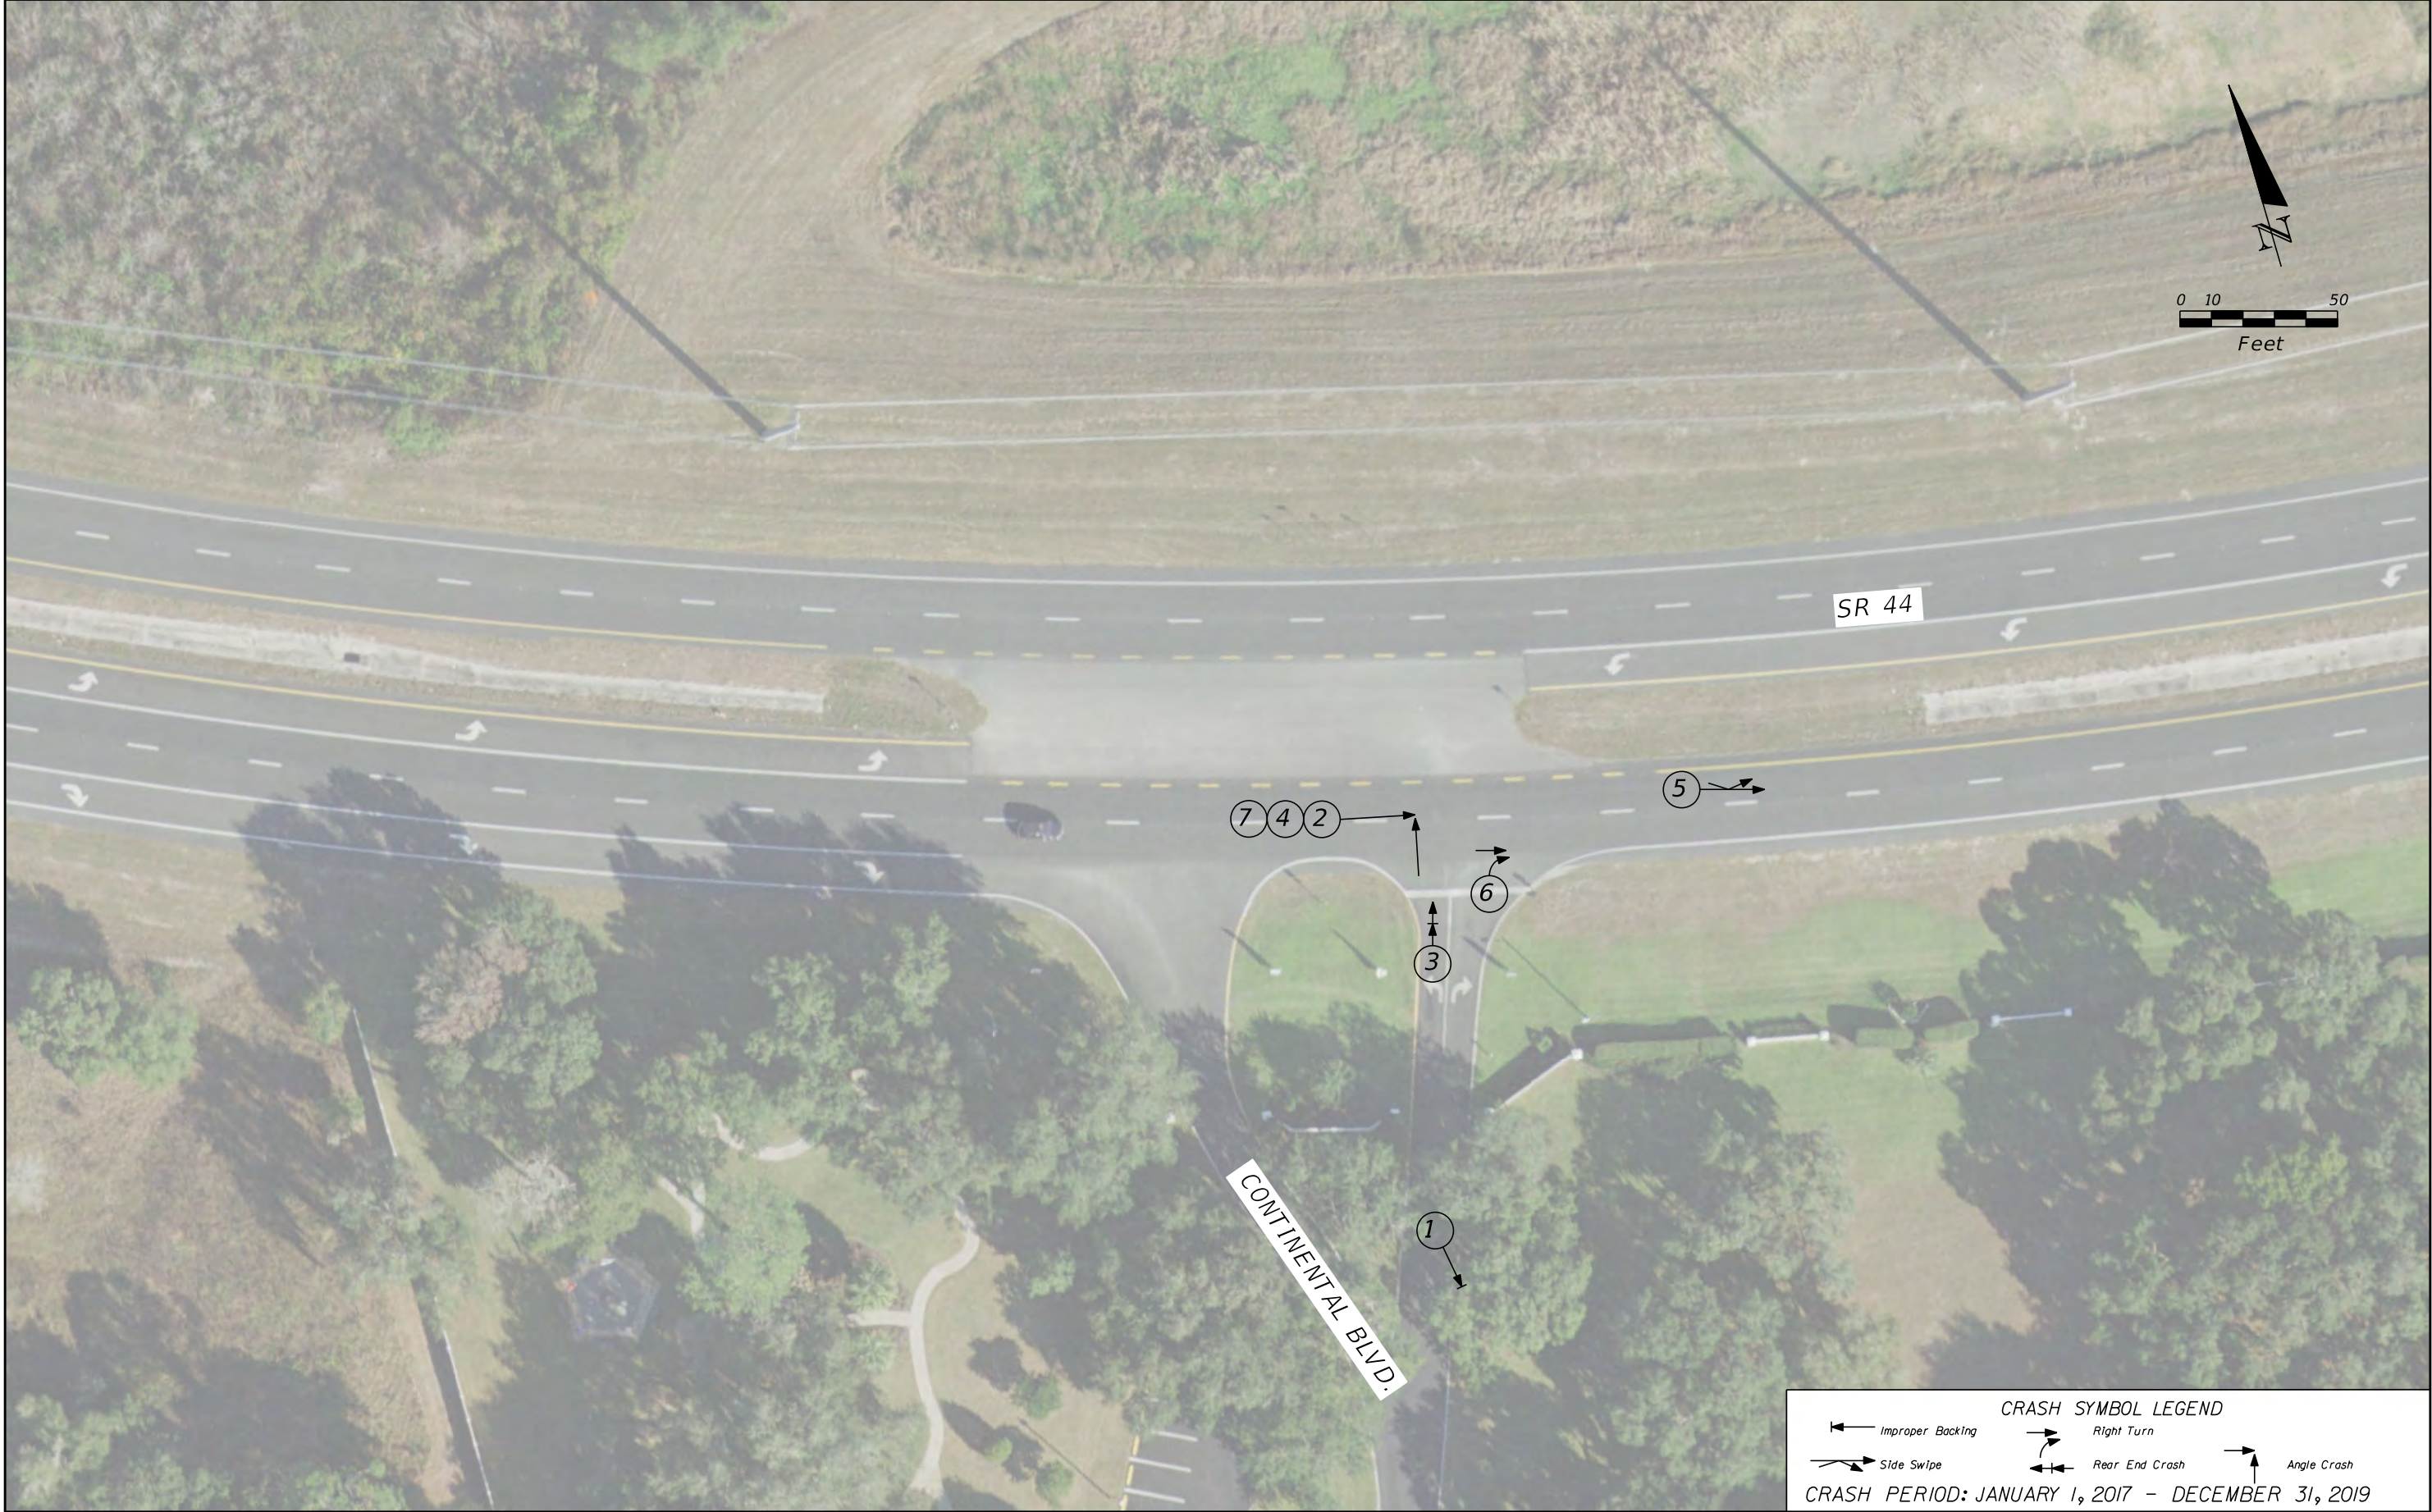
FIGURE NO.
2

There were five Property Damage Only (PDO) crashes of the seven reported crashes. These seven crashes resulted in a total of five injuries and zero fatalities. The three angle crashes involved a northbound vehicle performing a left-turn maneuver on to SR 44 to travel west. The contributing cause for all the three angle type crashes was failure to yield right-of-way.

The three angle crashes recorded over a three-year period are considered susceptible to correction by a traffic signal. The peak year with the highest incidence of angle crashes was in 2018 with two crashes which is lower than the five crashes required to satisfy the MUTCD crash warrant criteria.

The rear-end crash occurred along Continental Boulevard in the northbound left-turn, where the vehicle at fault followed too closely to the vehicle waiting to perform a northbound left-turn maneuver. The sideswipe crash occurred along eastbound SR 44 when a vehicle in the inside through lane changed lanes into the outside through lane. The hit a utility pole crash type occurred along Continental Boulevard, when the vehicle at fault realized he was traveling north on the southbound lanes and started to back out and hit a light pole. The right turn crash type occurred when northbound right turning vehicle failed to yield the right-of-way to the eastbound through vehicle.

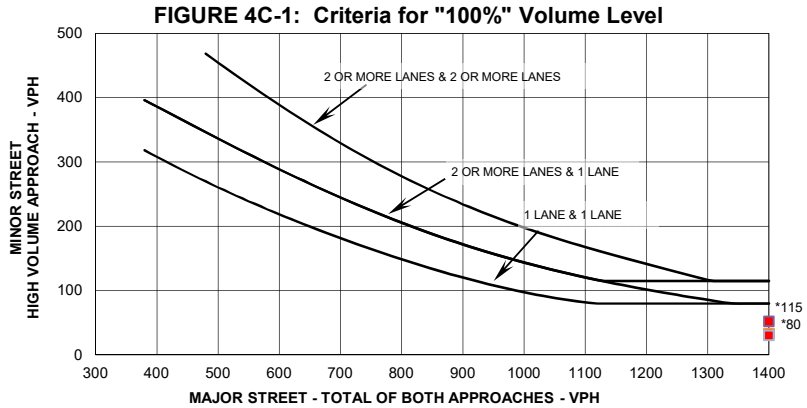
#### 100% Volume Level

Four Highest Hours	Volumes	
	Major Street	Minor Street
12:00 PM	2007	52
2:00 PM	2123	32
3:00 PM	2201	33
5:00 PM	2054	30

\* Note: 115 vph applies as the lower threshold volume for a minor street approach with two or more lanes and 80 vph applies as the lower threshold volume threshold for a minor street approach with one lane.

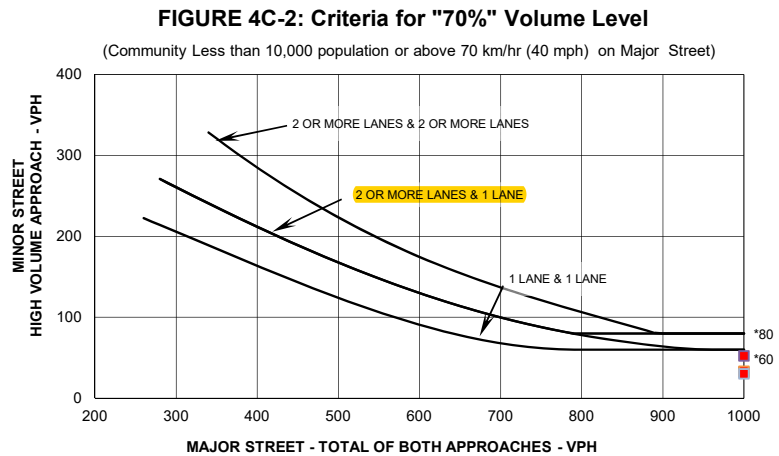
#### 70% Volume Level

Four Highest Hours	Volumes	
	Major Street	Minor Street
12:00 PM	2007	52
2:00 PM	2123	32
3:00 PM	2201	33
5:00 PM	2054	30

\* Note: 80 vph applies as the lower threshold volume for a minor street approach with two or more lanes and 60 vph applies as the lower threshold volume threshold for a minor street approach with one lane.
