STUDY OF LAKE OKAHUMPKA WATER LEVEL CHANGES DURING RAIN EVENT 12/16-17/2023

A case for relocating the automatic Water Level measuring Instrument

Dan Kane

3/1/2024

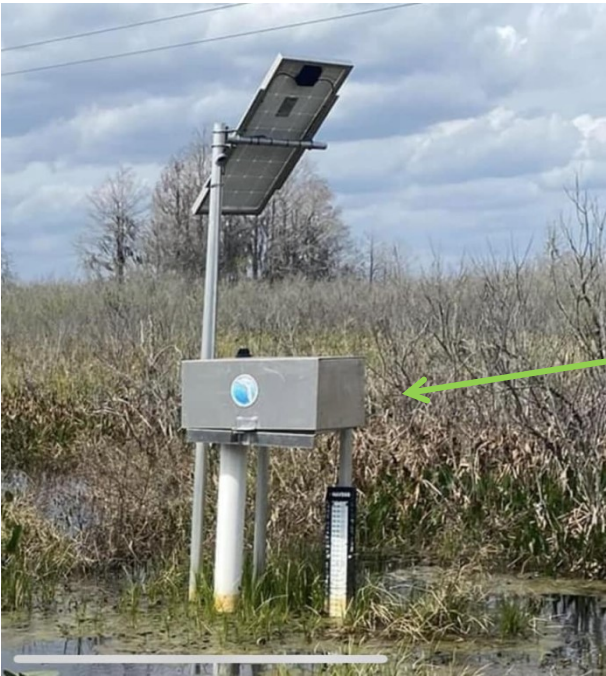
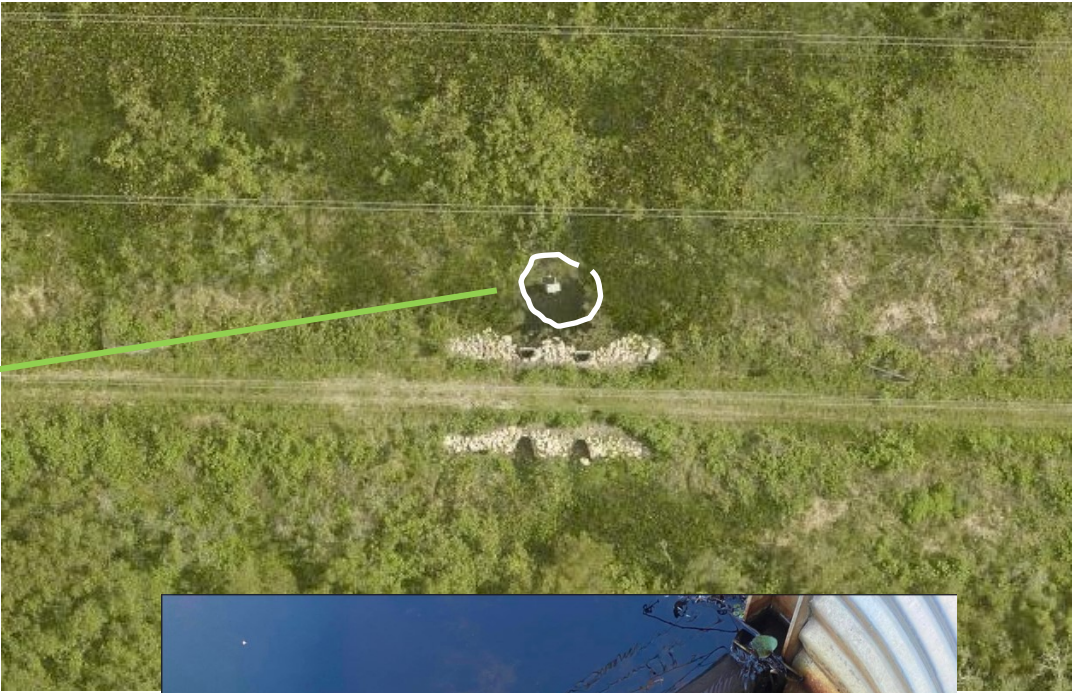
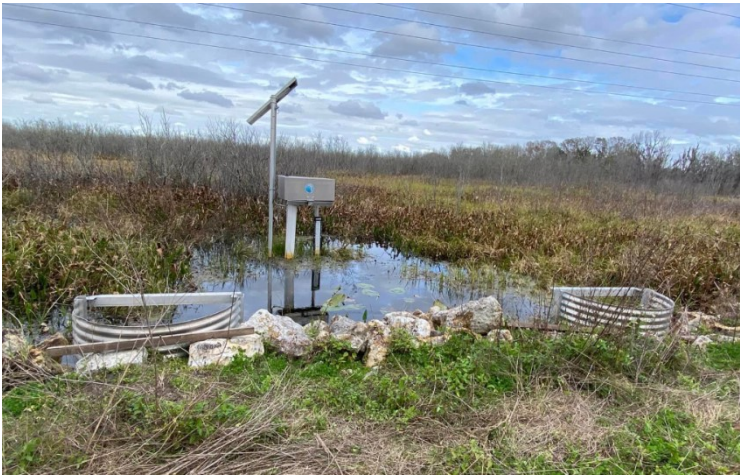
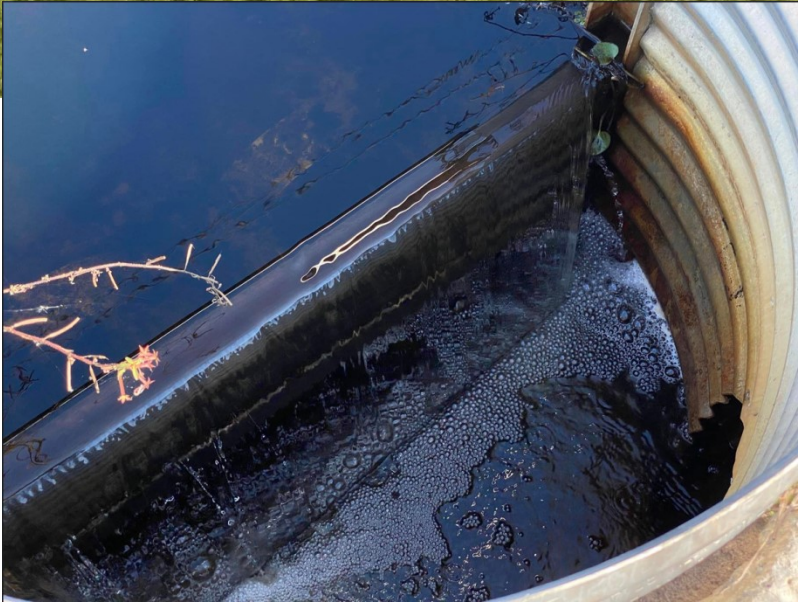
Solar powered reporting water level sensor with accompanying staff gauge
- this is currently near the weirs which control the lake level

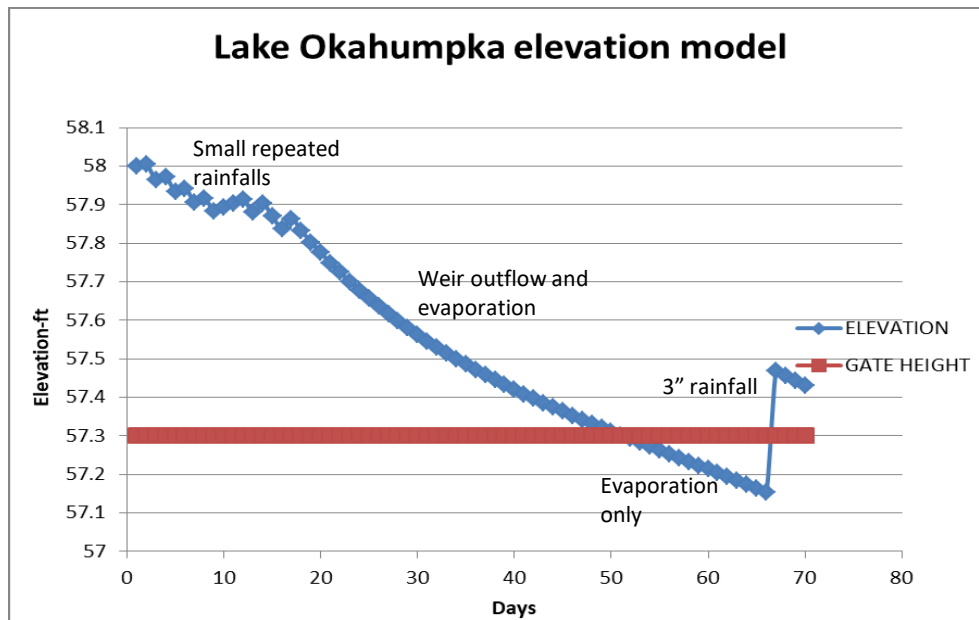
An excel based elevation model was constructed to understanding lake level variations

- Daily iteration
- Ability to add daily rainfall, initial elevation, weir elevation
- Bernoulli equation for weir outflow calculations
- Penman Formula for evaporation calculations

Initial elevation and Rainfall times/amounts are arbitrary variable used for illustration

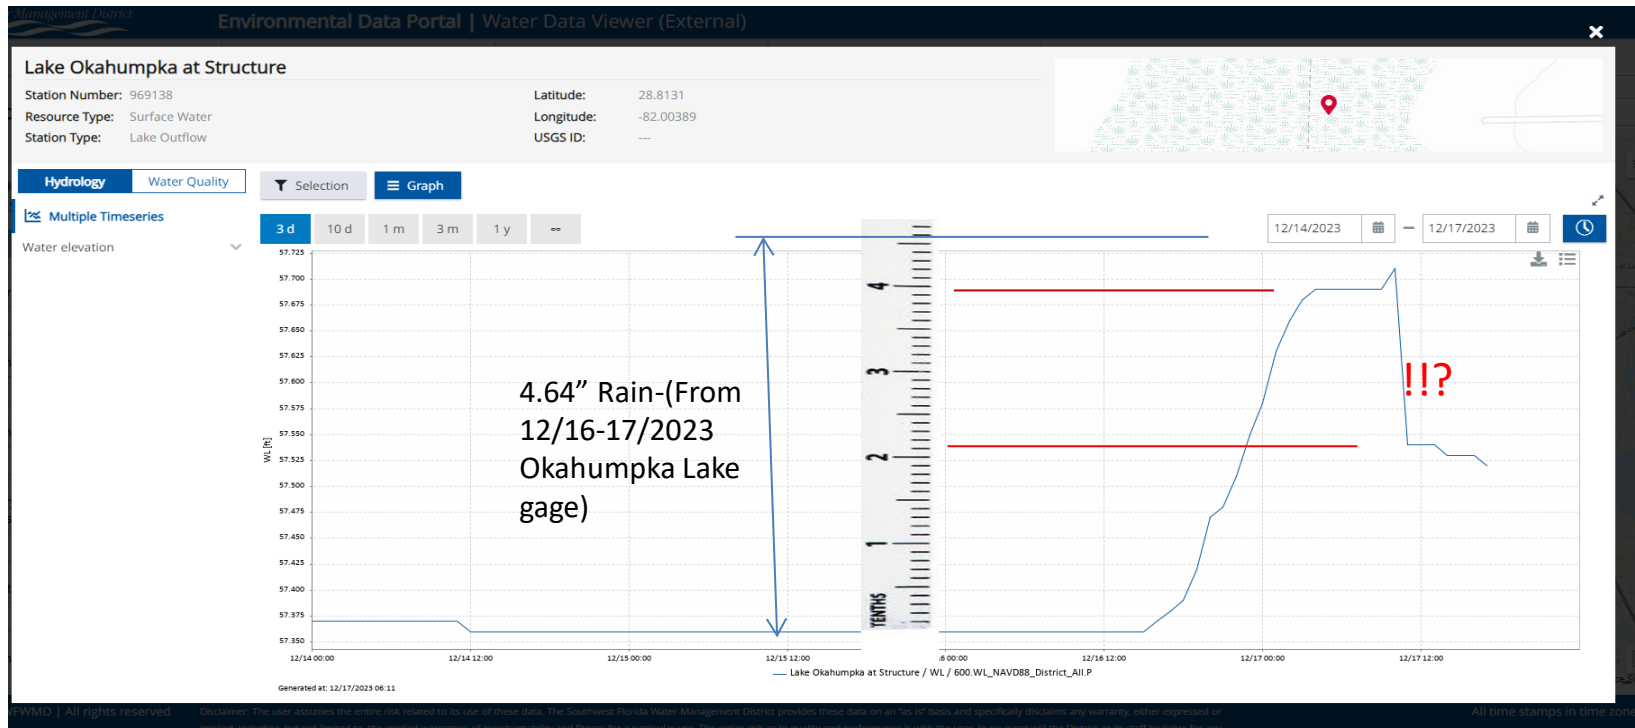
Lake Okahumpka structure-located water level gage levels

Although the water level change from the storm gage initially agreed reasonably with the rain gauge, its value precipitously dropped.

We have confidence in the Lake water level gage at the control structure based on excellent agreement between gage internet reported level and the value from the visual staff gage in photos. This from comparison of gauge report to staff gage level (photos) in the same day/hour.

We have since learned that height boards have been removed from the weirs. The timing of the rapid drop is coincident with the boards removal.

The boards were removed on Sunday morning 12/17/23, causing the rapid gage level change after that time. For that to occur without the lake dropping accordingly, the weir must be somewhat isolated from the Lake whereby there is a long lag between local weir upstream level and Lake levels. There must be restriction between the Lake and the weirs; difficult path, lake bottom ground shapes, and especially vegetation, etc.. A resulting small “basin”, in effect, near the weir might rapidly lower due to the removal of the boards. The slow movement of the water through the marsh cannot immediately replace the water gone through the weir.

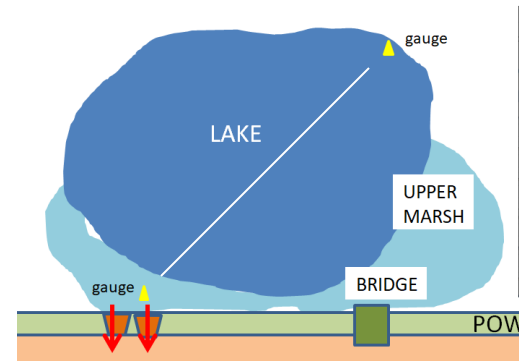
The two gauges read closely when the lake is 'settled'

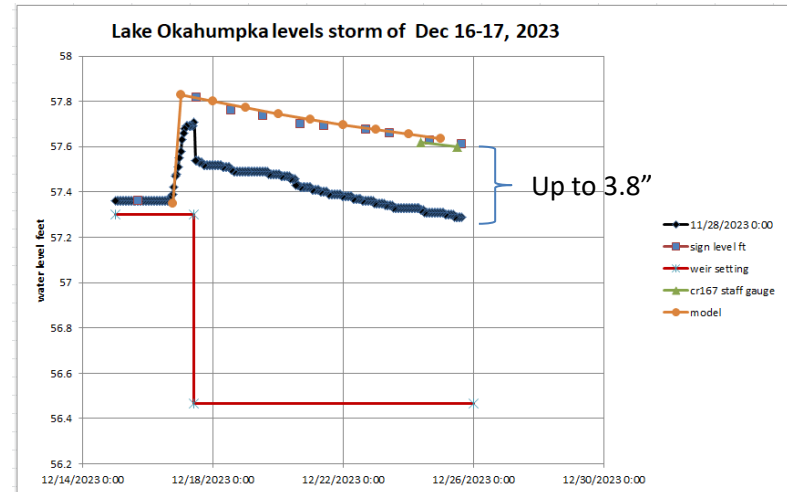
Actual Lake water level can be significantly higher than that measured at the weir structure

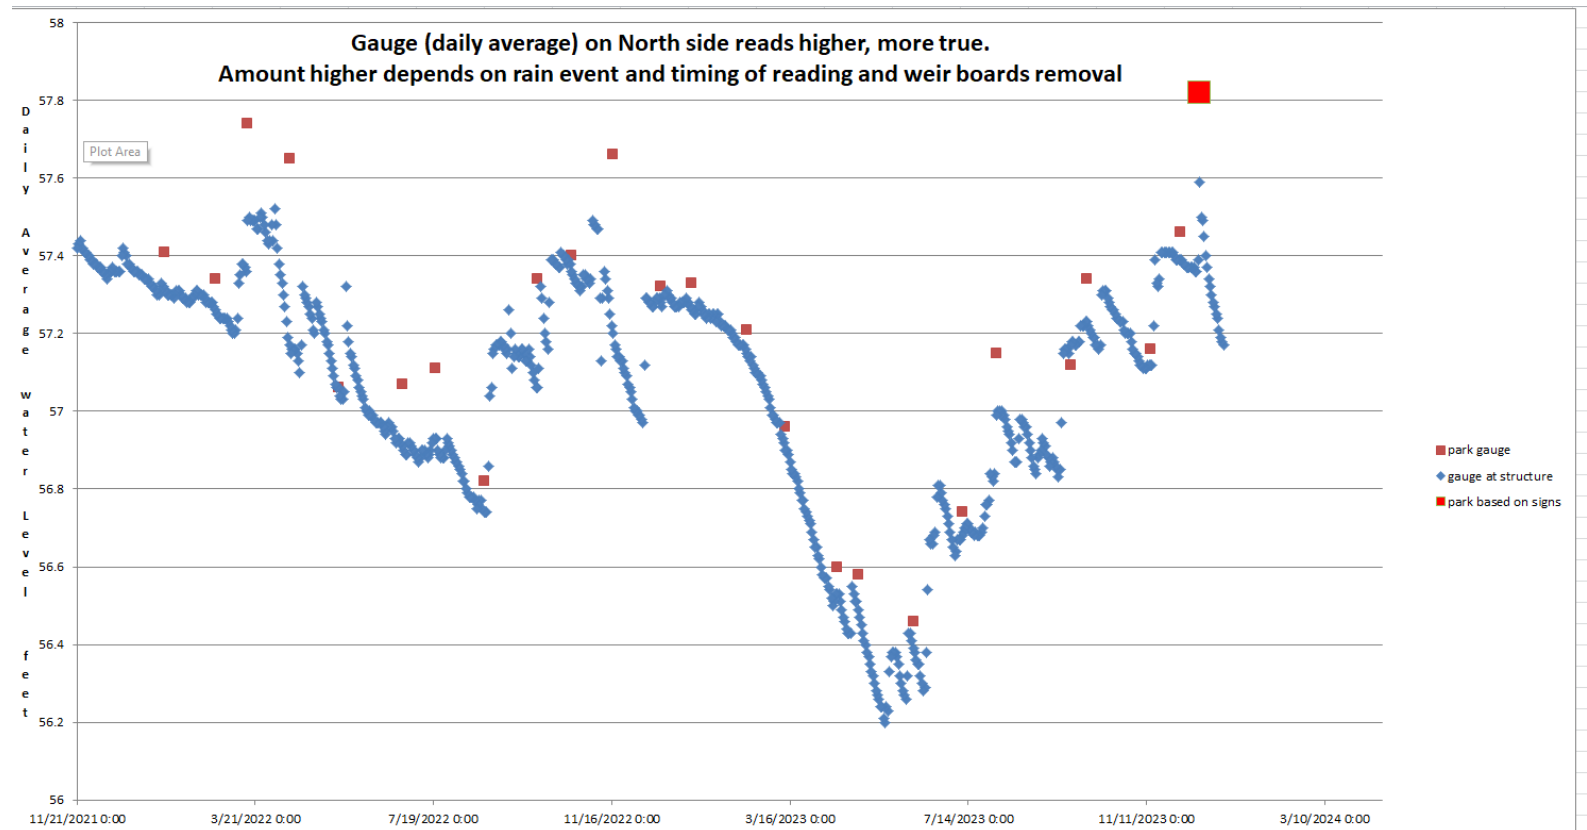
The below graph shows the difference in daily average water levels between the gauges at CR167 (lake North) and that at the structure.

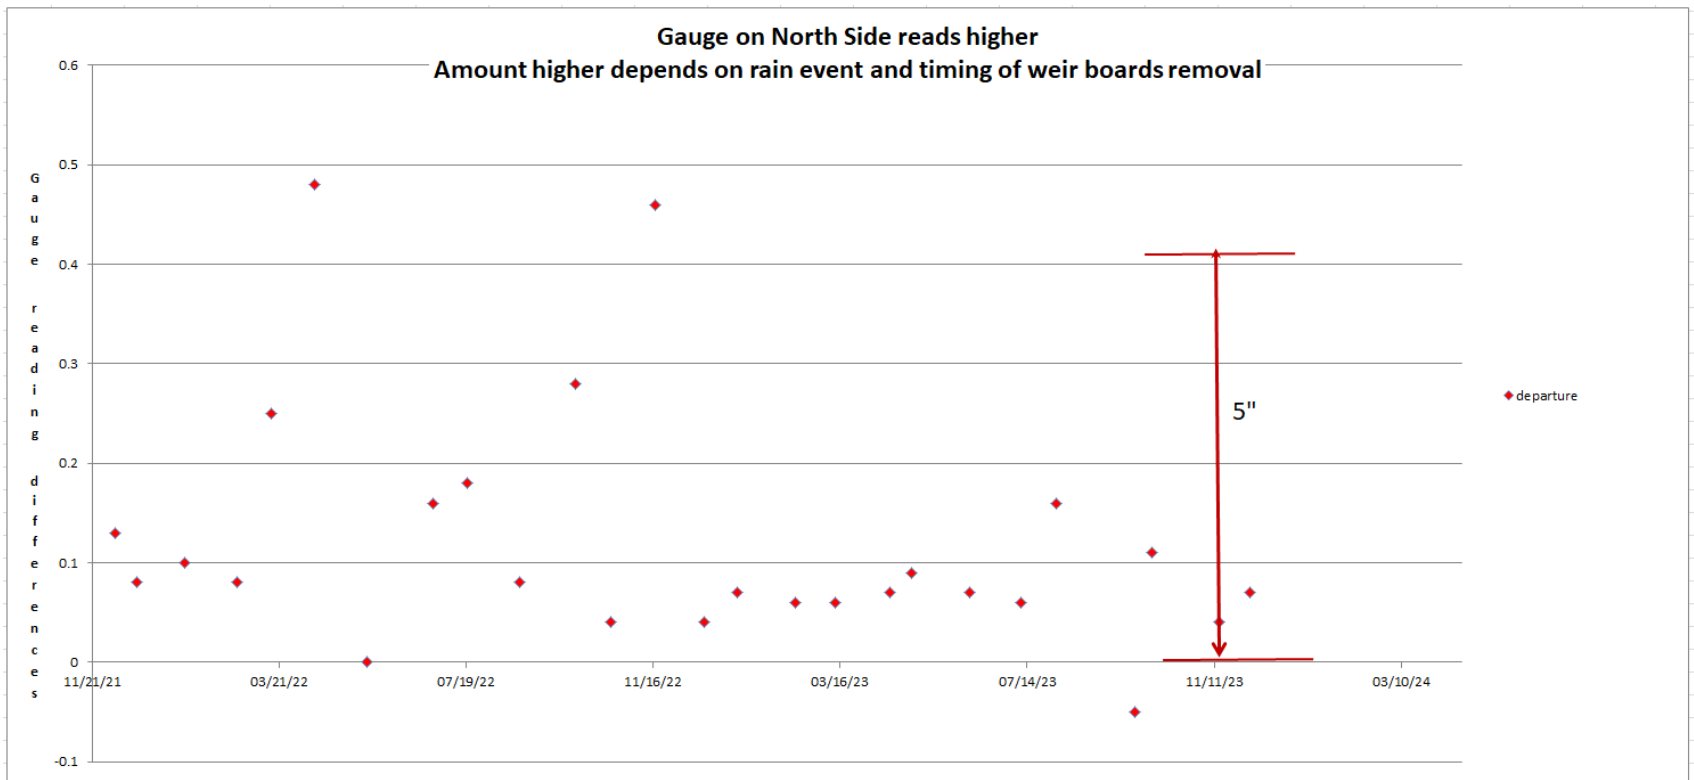
Lake Elevation Model and Gazebo sign observations provide good insight to lake level

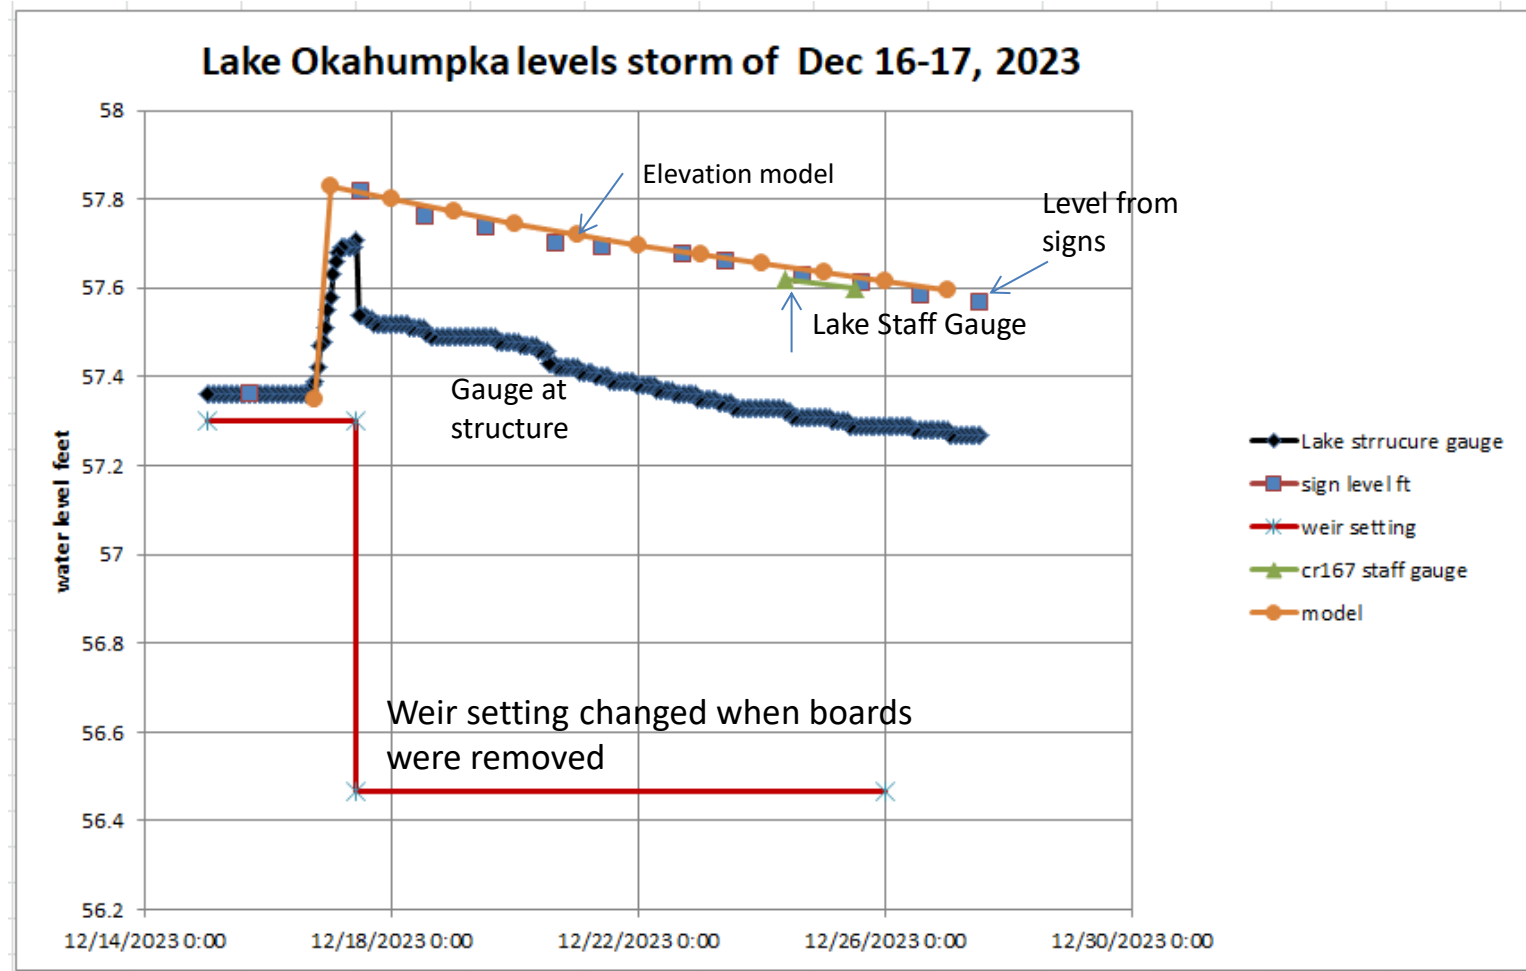
Simple excel model provides some understanding of mechanisms affecting lake levels

- Rainfall
- Weir outflow (Bernoulli equation)
- Evaporation (Penman formula)

INPUT	
starting height	feet 57.36
gage height	feet 57.3
b, wier width each	feet 4
number of wiers in paralel	2 feet both 8
WEIR FLOW CORRECTION	0.6
RAINFALL CORR DRAINAGE FROM ENVIR	1.25
EVAPORATION CORRECTION	0.5
	RAIN DAY inches
	1 2 3 4 5 6 7 8 9 10
1	0 4.7 0 0 0 0 0 0 0 0
11	0 0 0 0 0 0 0 0 0 0
21	0 0 0 0 0 0 0 0 0 0
31	0 0 0 0 0 0 0 0 0 0
41	0 0 0 0 0 0 0 0 0 0
51	0 0 0 0 0 0 0 0 0 0
61	0 0 0 0 0 0 0 0 0 0
71	0 0 0 0 0 0 0 0 0 0
81	0 0 0 0 0 0 0 0 0 0
91	0 0 0 0 0 0 0 0 0 0
111	0 0 0 0 0 0 0 0 0 0
110	0 0 0 0 0 0 0 0 0 0

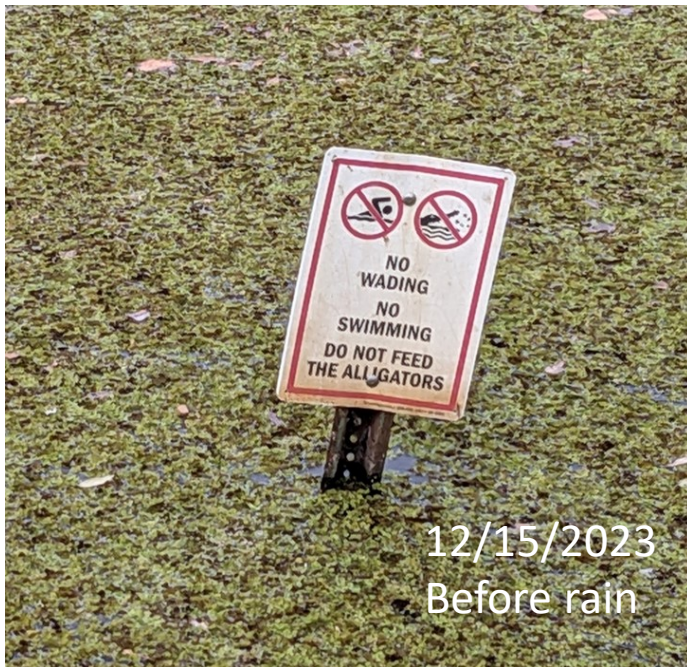
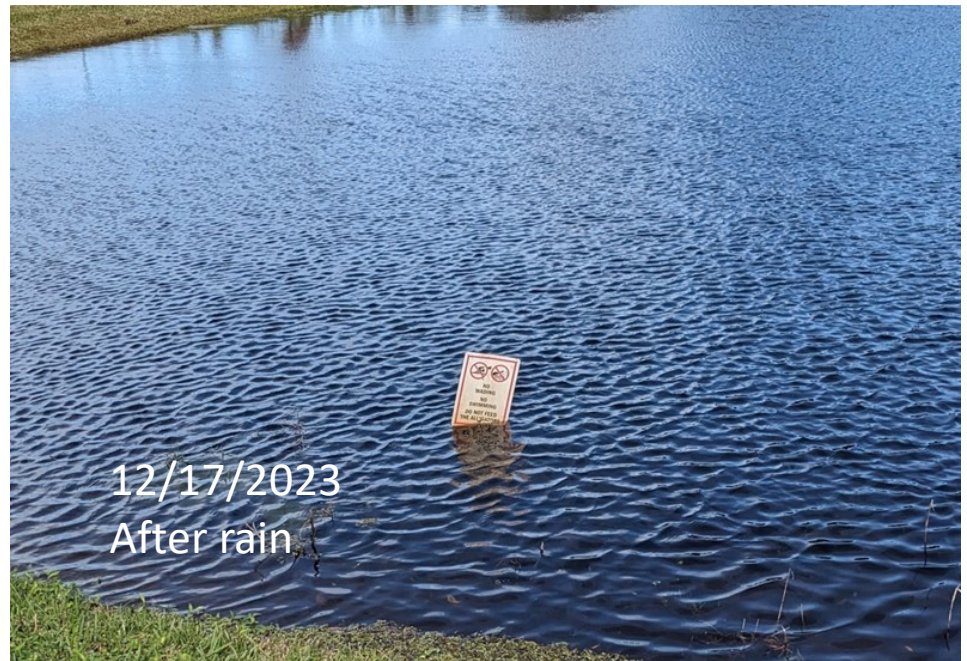
Rain gage near Lake Okahumpka shows 4.64" of total rainfall during 12/16-17/2023

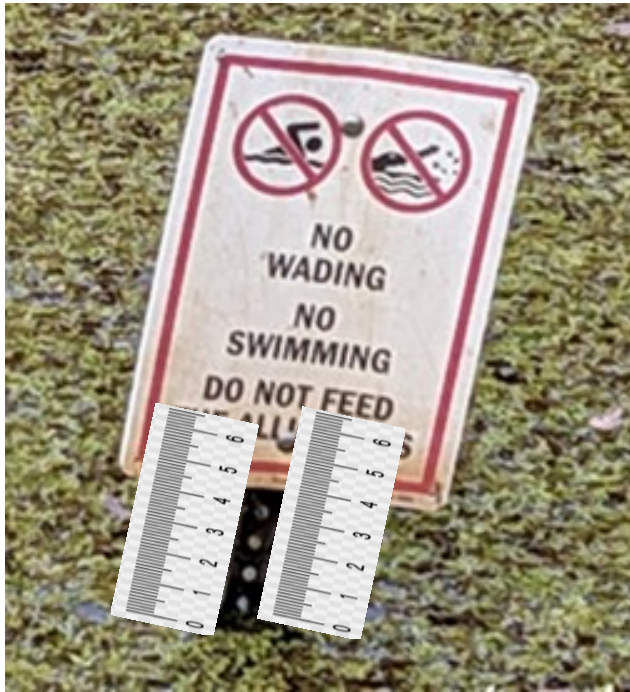
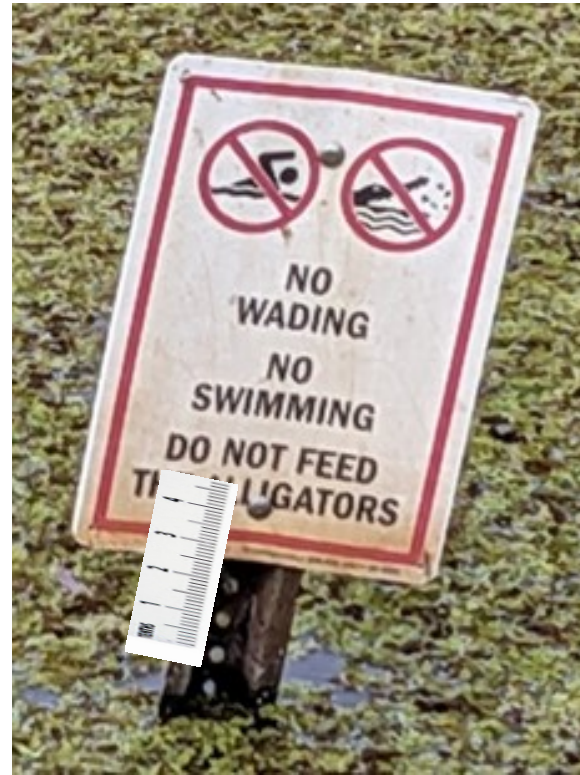
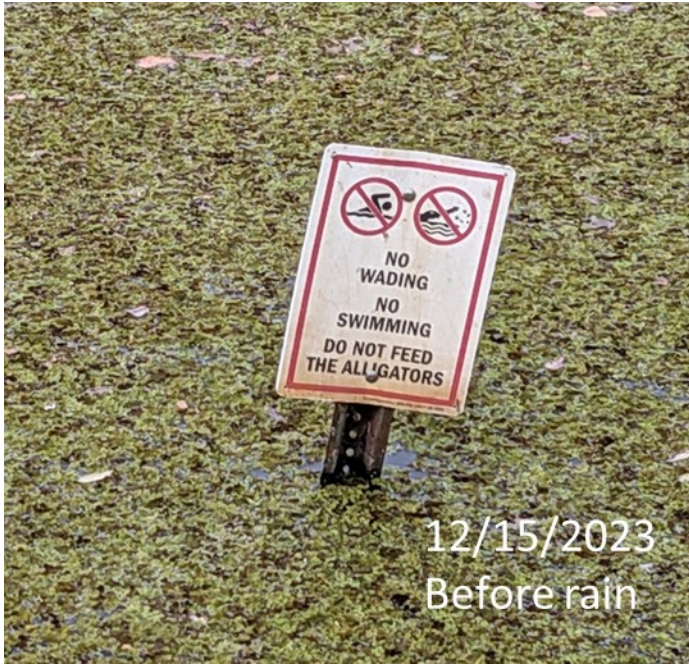
Establishing canal sign-water level reference for our crude 'staff gauge'

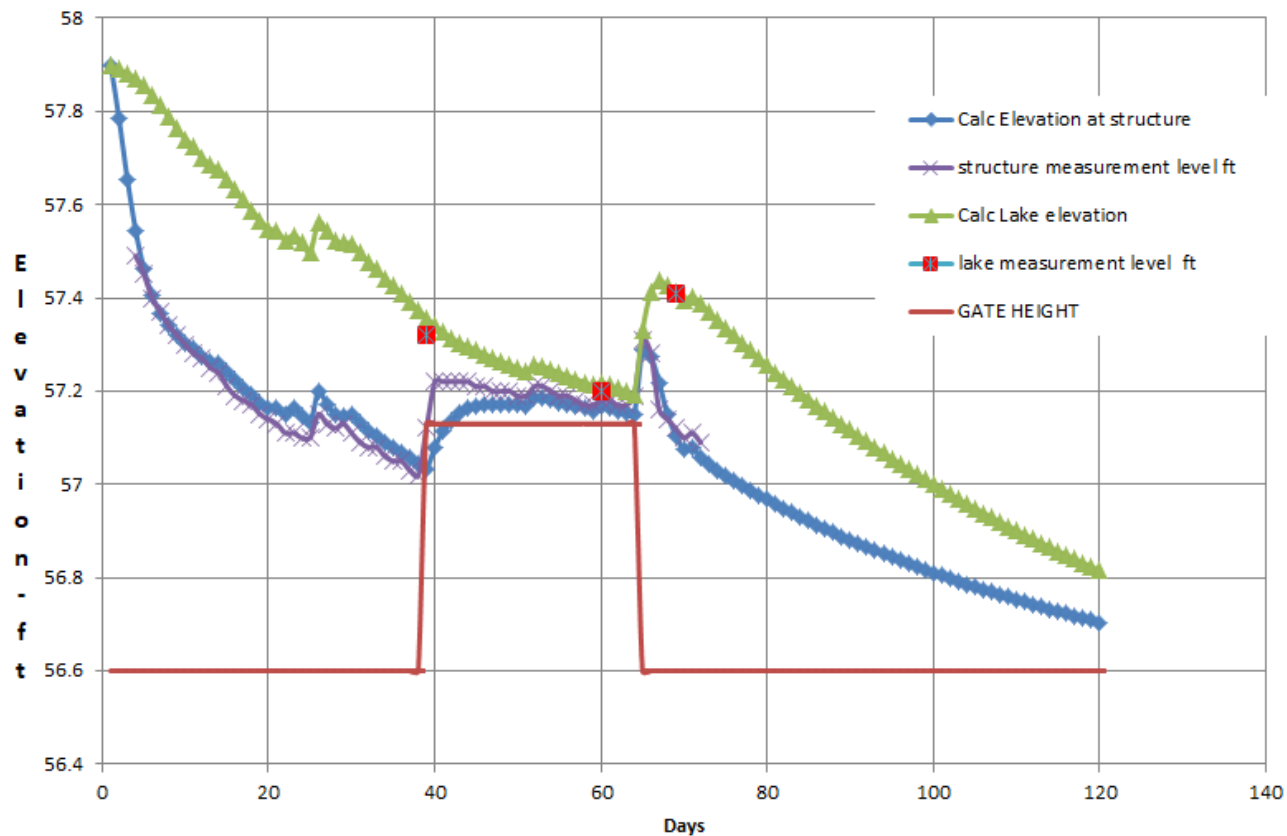
Lake Okahumpka elevation model starting at time of removal of boards after Dec 16/17 2023 storm

The model has been advanced to predict the lake level at both measuring locations. Good agreement is seen versus actual data.

-note scarcity of data from the 'park' gauge

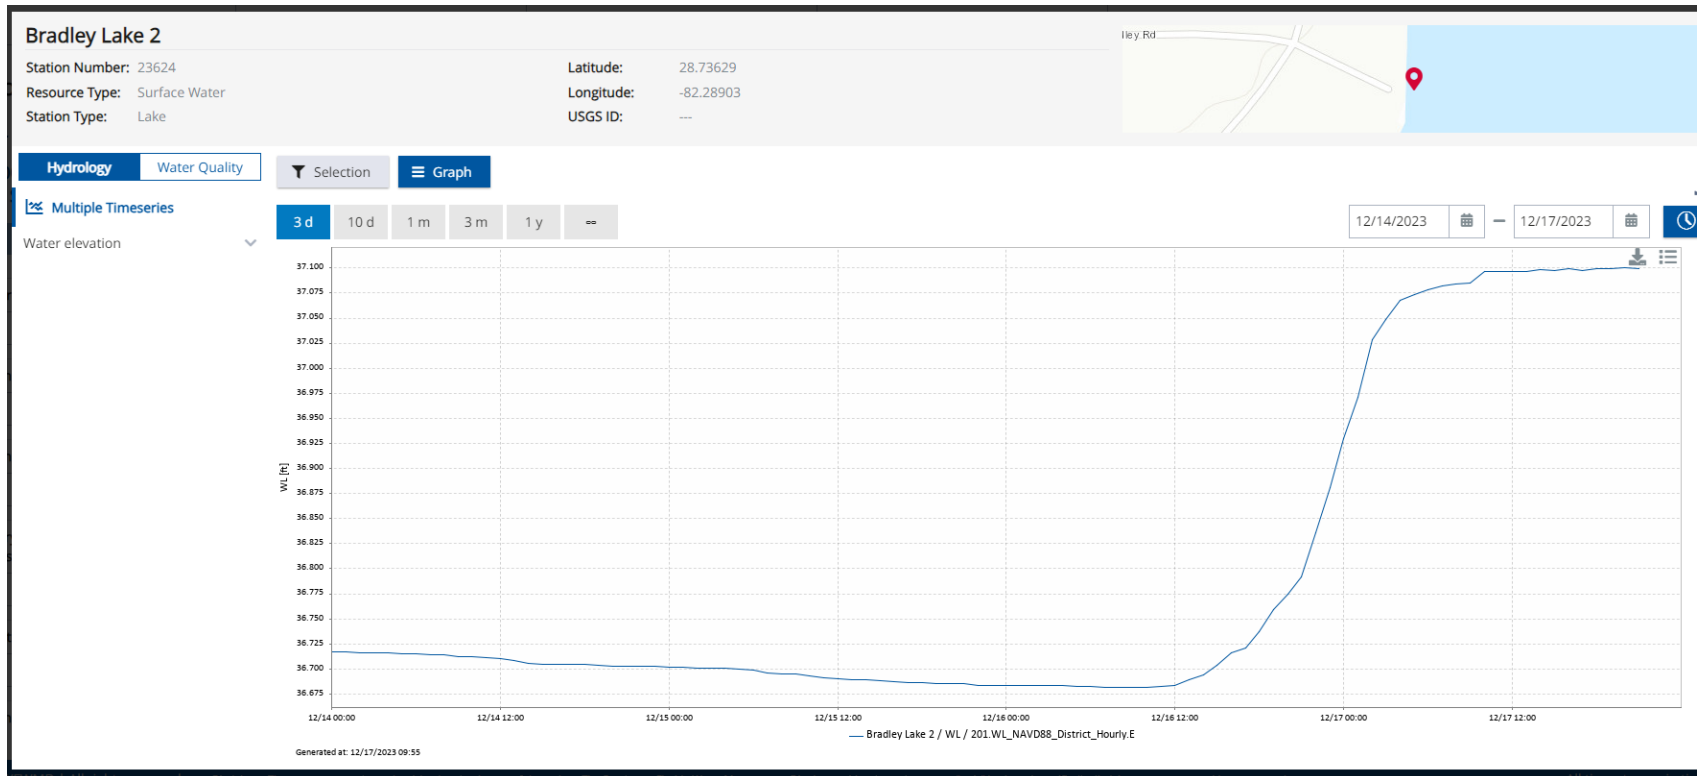
Ref: Rain gauge at Bradley Lake (Floral City) shows 5.02” of total rainfall during that same 12/16-17/2023 storm.

There was no rapid drop in level. Gauge is not at a water level control structure, and is exposed directly to its lake.
